American Freedom Train No. 1

Cosmetic Restoration Process

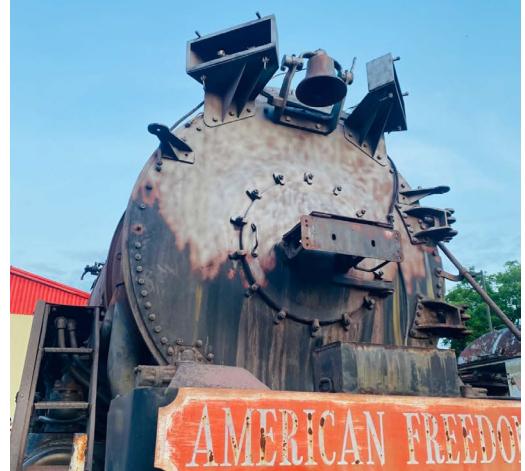
What condition was the locomotive in before restoration began?

Before restoration, the locomotive showed widespread paint loss and discoloration, extensive corrosion of the exterior metal jacketing, failing internal spacers, and deterioration of decorative and mechanical exterior elements. Some original components were missing or damaged, and earlier paint applied as a temporary fix had fully failed.

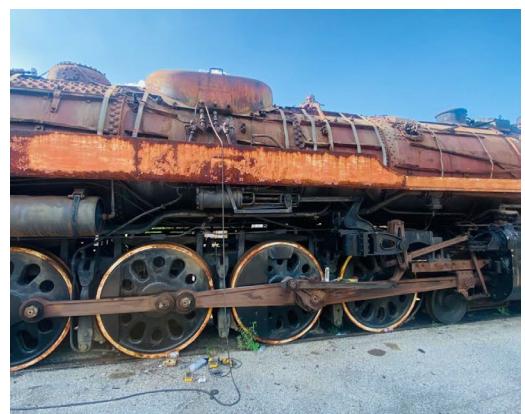
What happened during the disassembly phase?

Restoration began with careful disassembly of exterior components, including removal of metal jacketing, skirting, and selected appliances. Each piece was labeled, documented, and evaluated to determine whether it could be conserved or needed replacement. Original materials were retained whenever possible and used as templates when replacement was required.

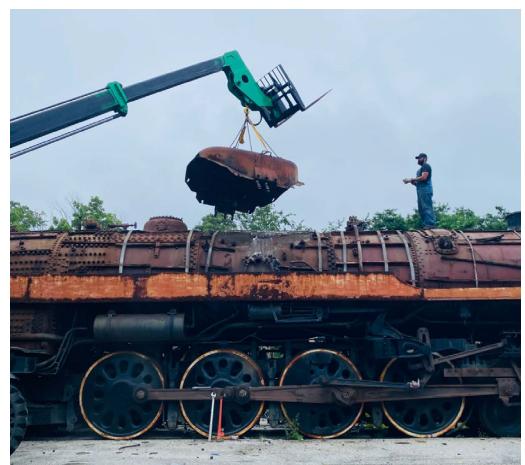
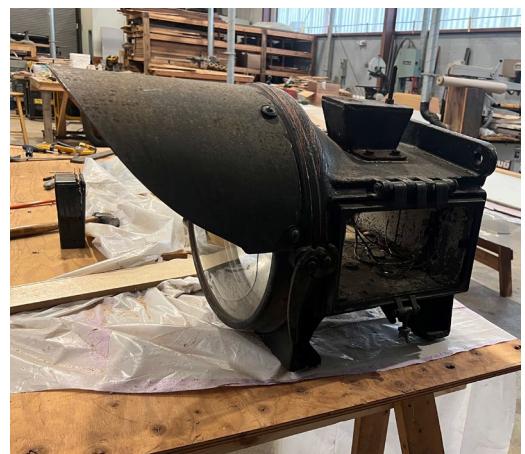
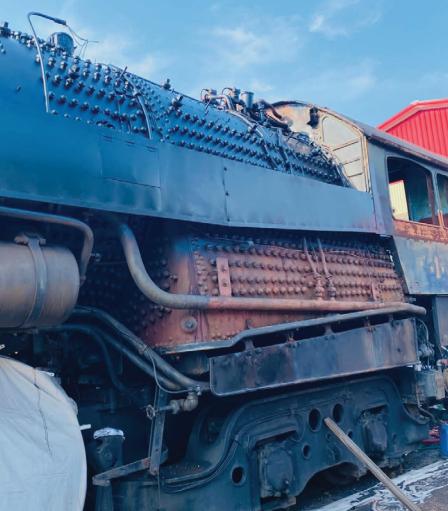
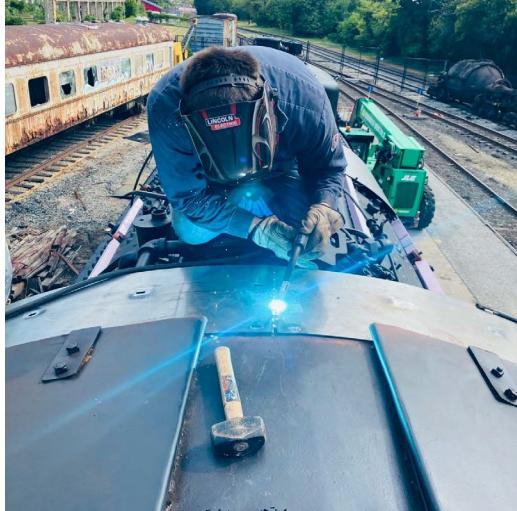
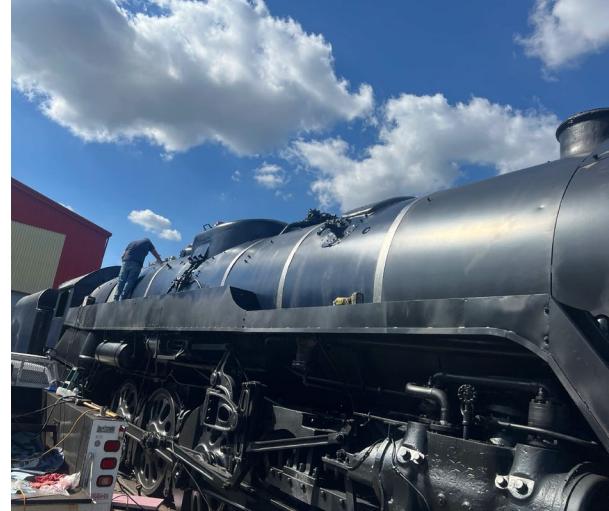
What was done to address corrosion and metal deterioration?

All exposed metal surfaces were cleaned using media blasting to remove corrosion, failing paint, and contaminants. Areas of rust-through or structural failure were repaired or replaced. New steel jacketing was fabricated where original panels could not be saved, using original pieces as patterns to ensure accuracy.

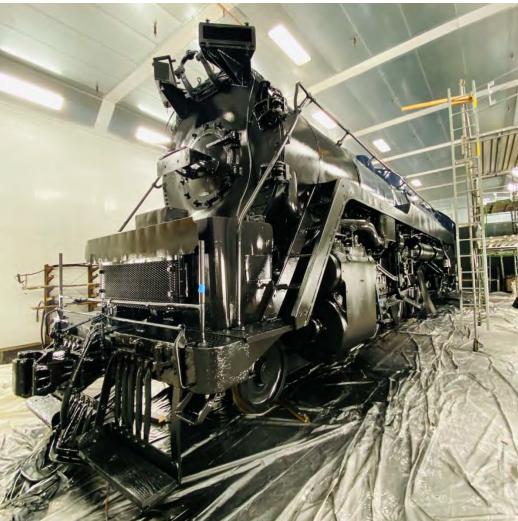
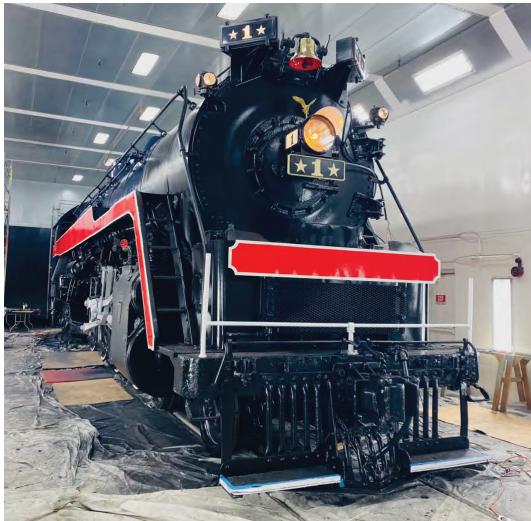
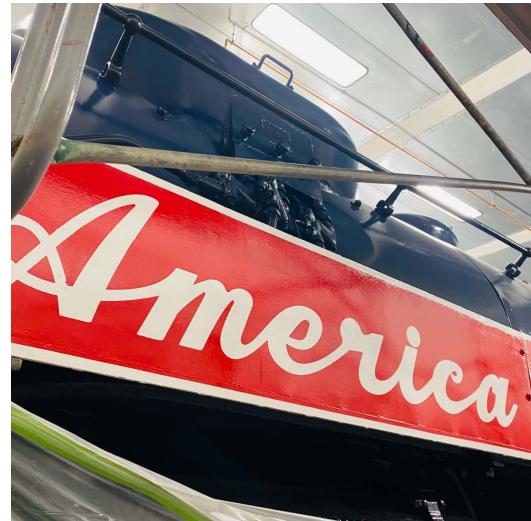
Why did the jacketing need to be replaced?

The original jacketing had deteriorated significantly, with rust-through and failing internal spacers. New jacketing was required to stabilize the exterior, prevent further corrosion, and create a sound surface for repainting. New internal spacer materials were installed to properly separate the boiler from the jacketing.

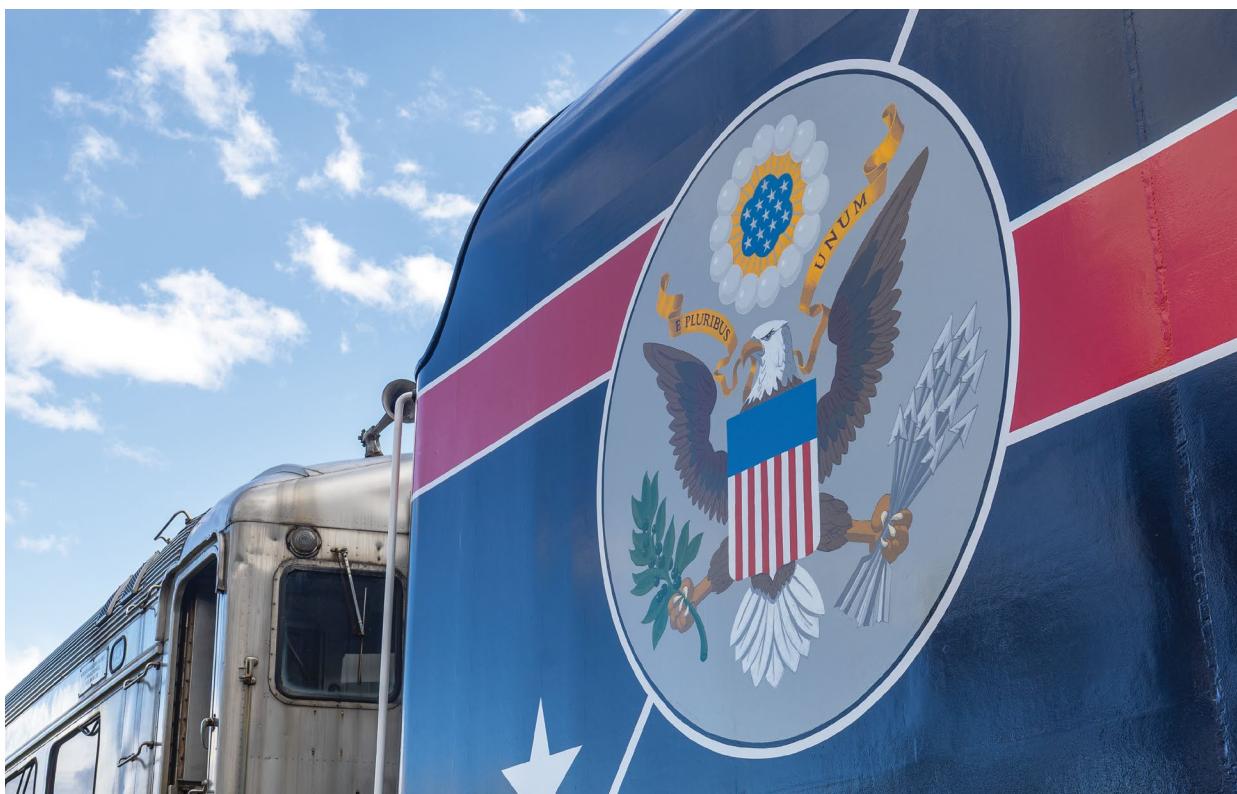
Was the artwork on the tender recreated by hand?

Yes. The iconic eagle and seals were hand painted by artists David and Liné Tutwiler, following historical references, before protective clear coats were applied. David has a long relationship with the American Freedom Train. During the Bicentennial, his painting *American Freedom Train* was purchased by Pepsi Co., one of the Bicentennial sponsors, for display in their corporate offices. Pepsi also later hired David to ride in the cab from Ogden, Utah, to Boise, Idaho, to create additional works of the train and capture its journey throughout the Western side of the country.

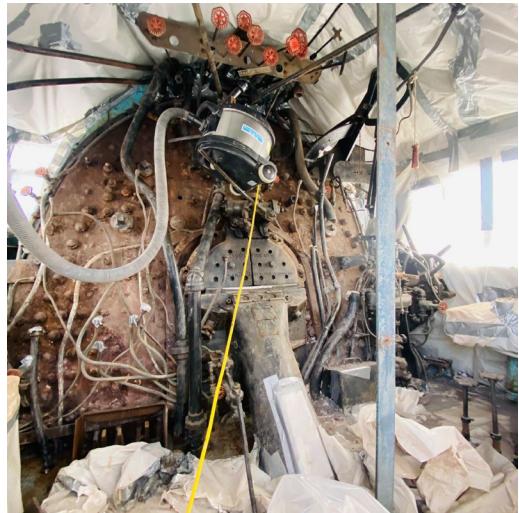
What work was done on the cab interior?

The cab interior underwent conservation and cosmetic restoration, including repainting, repair of wood components, restoration of windows and frames, and stabilization of remaining fixtures. The goal was to preserve original materials while presenting the cab as it would have appeared during the Bicentennial era.

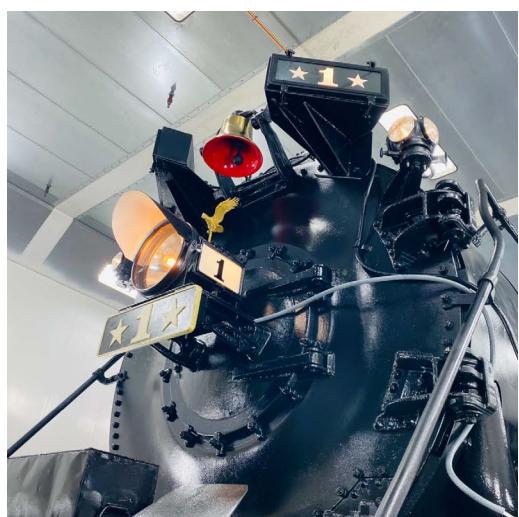
Were missing or damaged exterior elements replaced?

Yes. Missing or damaged decorative and functional exterior elements—such as number boards, lighting components, metal trim, and the nose-mounted eagle—were either restored or accurately replicated using historical documentation and surviving examples.

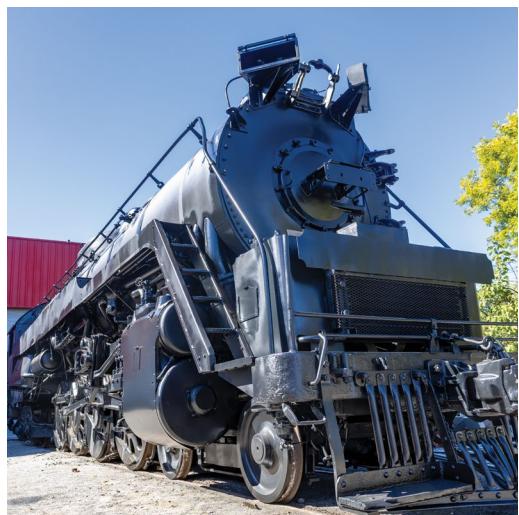
Was any electrical work performed?

Electrical systems for headlights, marker lights, class lights, and cab illumination were inspected, repaired as needed, and rewired to operate safely on standard electrical power for display purposes.
